Manhole Inspection Summary

Manhole # S21YY1015MH

Insp Date: **11/27/06 2:53 PM**

Location Address: **24 FALLS RD**

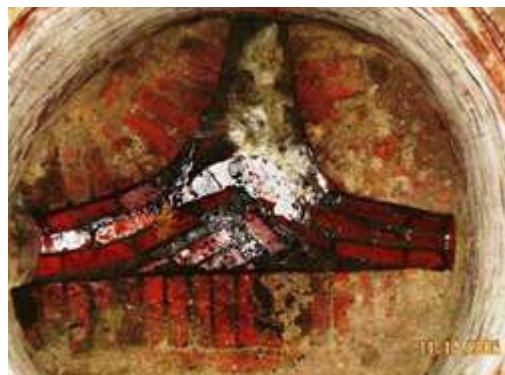
Top View

☒ **Debris** (not Condition related)

Bench and Channel debris.

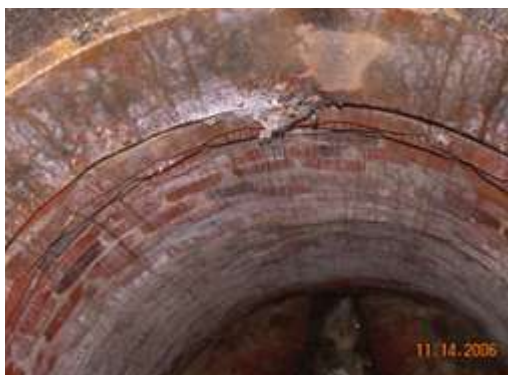
Defect

Infiltration: ☐ None ☒ **Joint** ☐ Cracks ☒ **Mortar** ☐ Roots ☐ Wall

Infiltration: ☐ None ☐ Joint ☐ Cracks ☒ **Mortar** ☐ Roots ☒ **Wall**

Adjustment and Barrel infiltration.

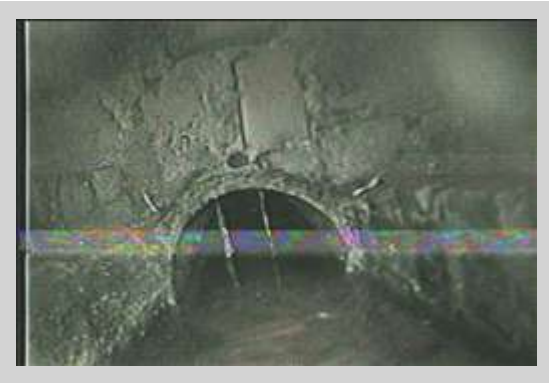
8 in. Circular Gravity Sewer Pipe Out @ 12 O'Clock

Infiltration: **Evidence** Pipe Seal Cond: **Unknown**

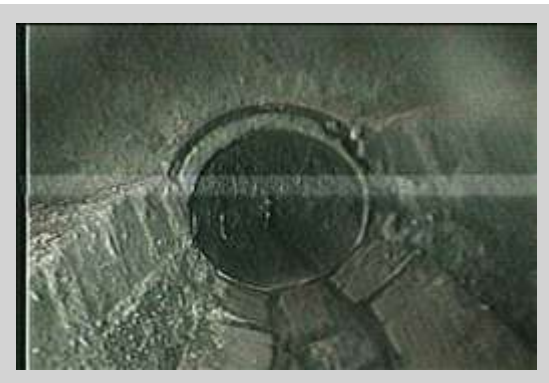
6 in. Circular Gravity Sewer Pipe In @ 3 O'Clock

ROOTS IN PIPE

Infiltration: **Evidence** Pipe Seal Cond: **Unknown**

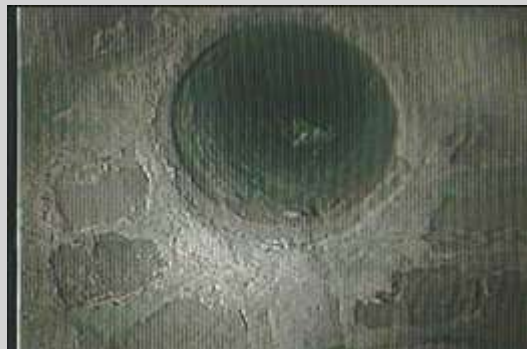
Pipe In @ 9 O'Clock

Infiltration: **Evidence**

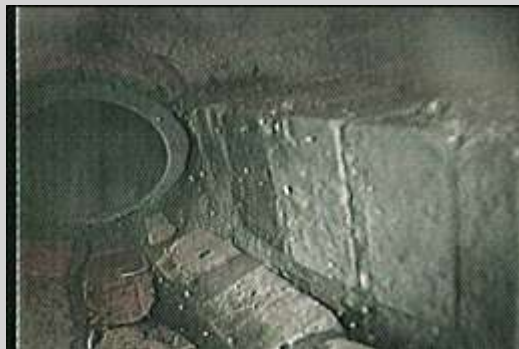
Drop In @ 9 O'Clock

Condition: ☐ Sound ☐ Cracked ☐ Root Intrusion ☒ **Deteriorated** ☐ Leaks ☐ Debris

Channel deterioration.
